# ***A-Tech Inspection Services***

## **lac2 Complete Mold Inspection Report**

123 Mold St, Anytown NY, 12345

Inspection Date: 8/10/2010 Time: 12:00 P.M.

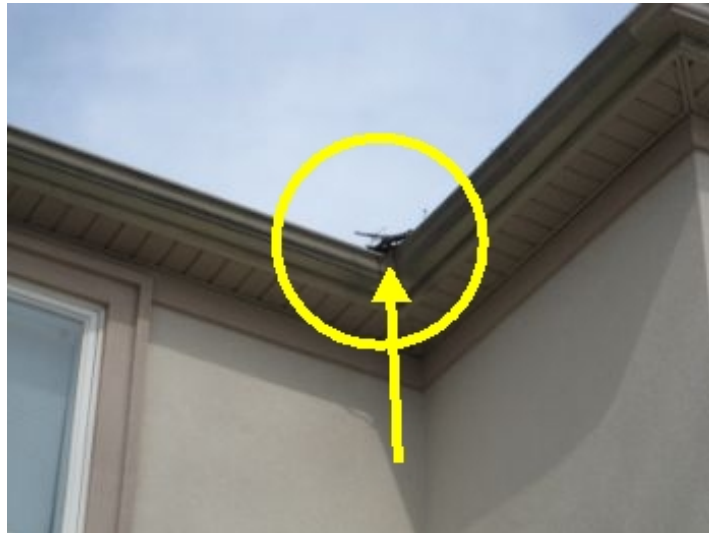
The gutters are restricted by debris. If the water runoff from the roof is not allowed to drain freely and properly through the gutter system, a backup of water will occur and can make its way under the roofing materials and into the house.

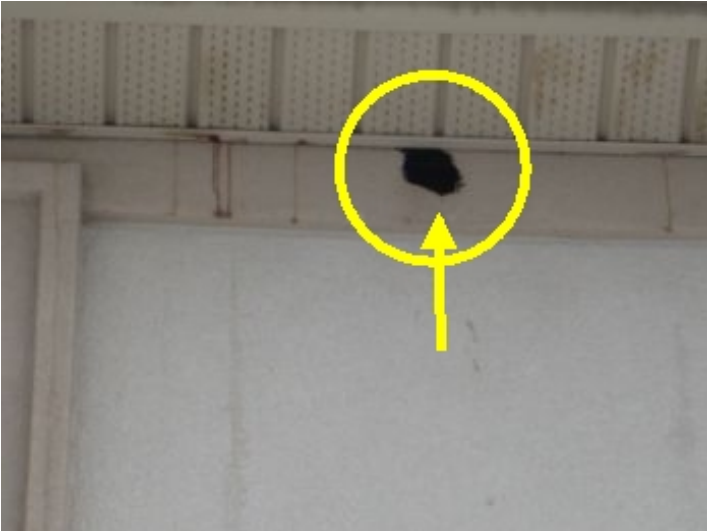
Note: Hole in stucco look siding, recommend further evaluation and or repairs to prevent moisture, animal or insect entry.

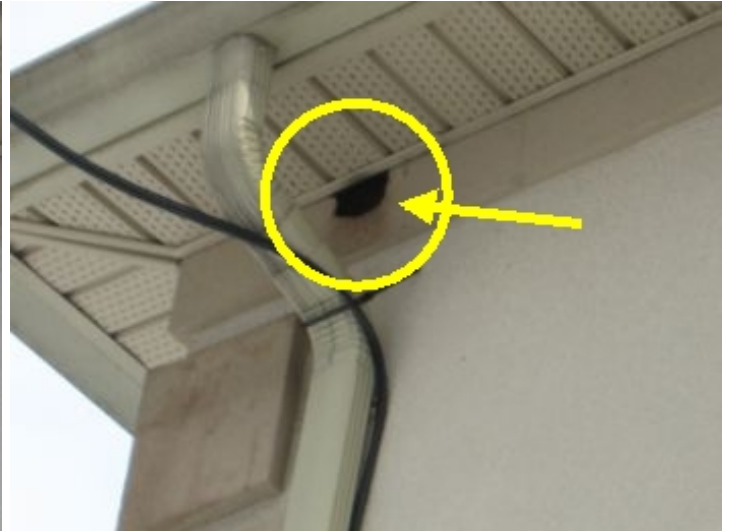
Note: Hole in stucco look siding, recommend further evaluation and or repairs to prevent moisture, animal or insect entry.

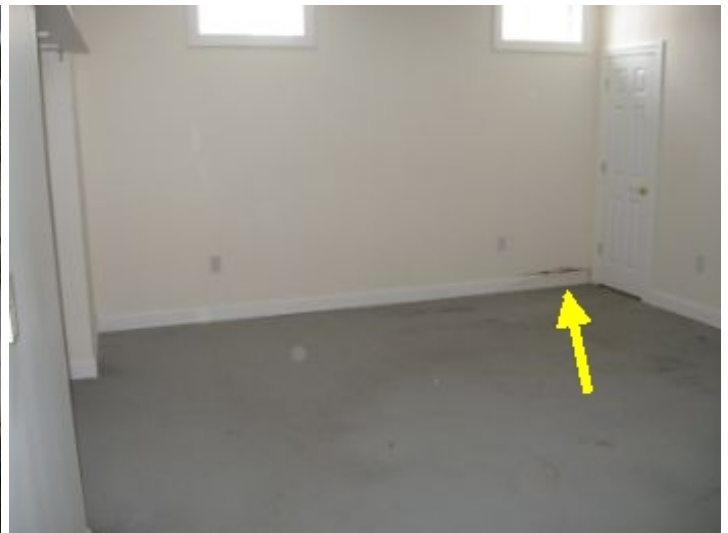
There appears to be moisture present in the exterior walls. We recommend having a licensed contractor evaluate this condition and provide repair options.

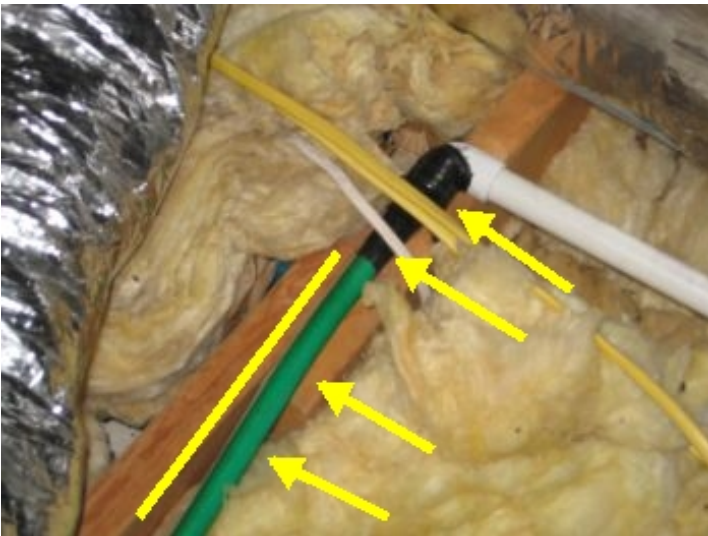
Advise condensate pump drain line damaged and leaking, improperly repaired. Water damage and mold like substance visible, bio slide and air quality tests completed.

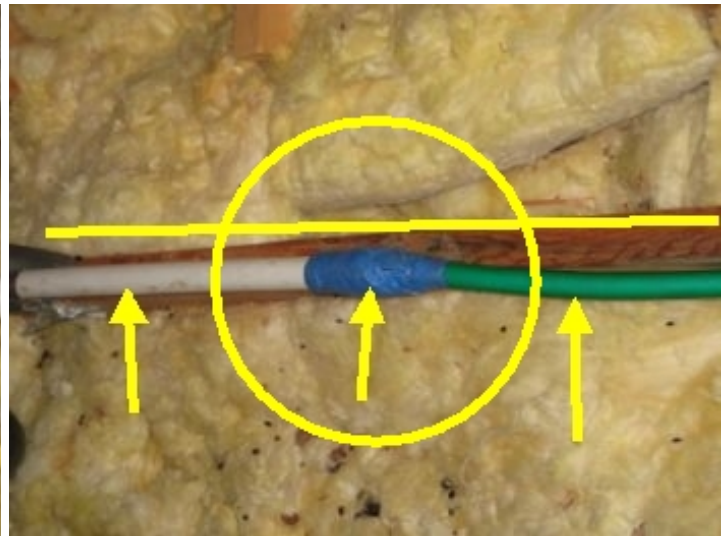
Advise condensate pump drain line damaged and leaking, improperly repaired. Water damage and mold like substance visible, bio slide and air quality tests completed.

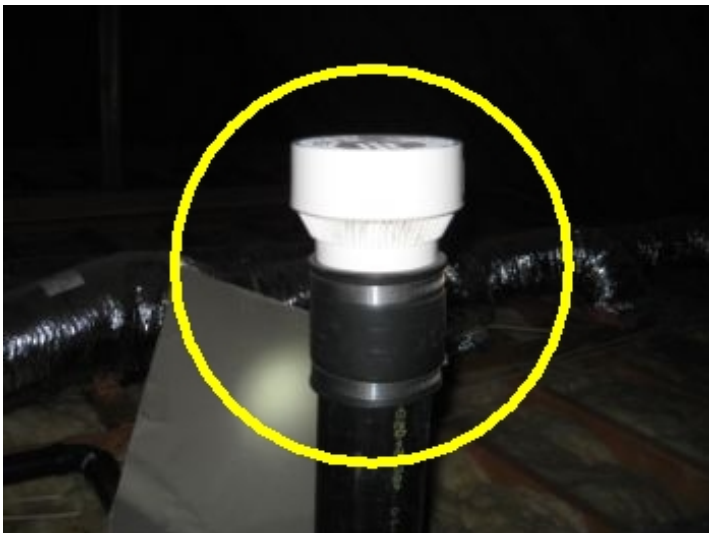
Recommend upgrade to plumbing vent that terminates in the attic.(see photo) This will lead to sewer gas and moisture in attic area.

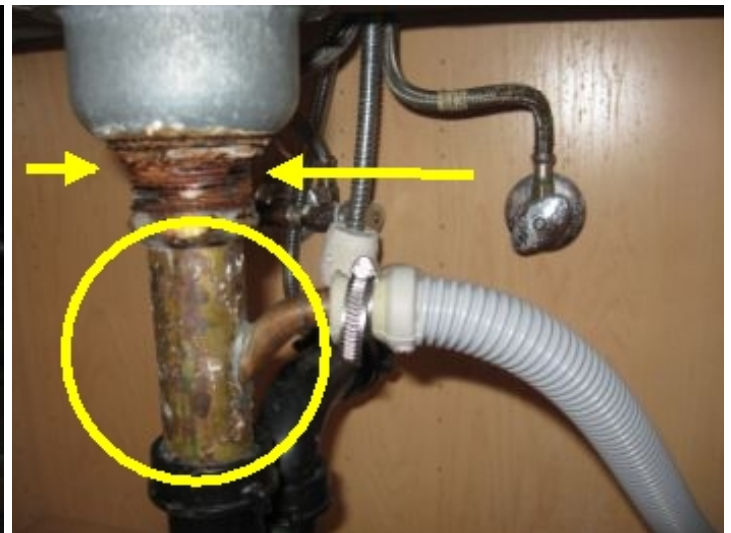
Note: some drains show signs of previous leaks, recommend closely monitor or repair suspected leaks.(see photo)

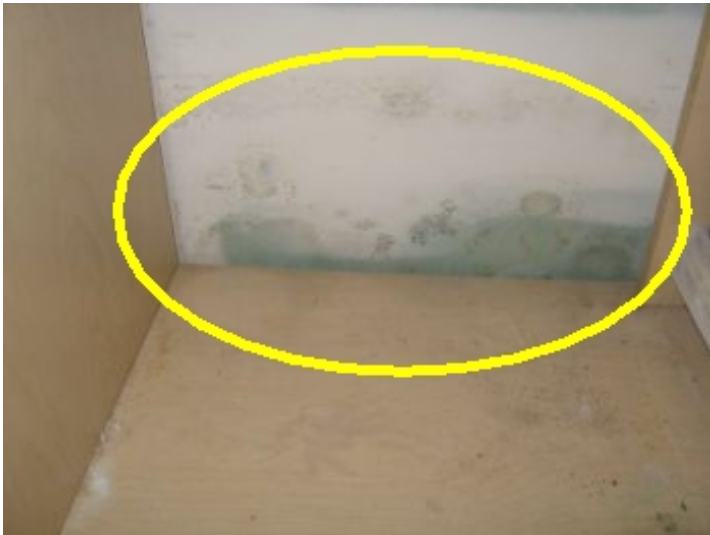
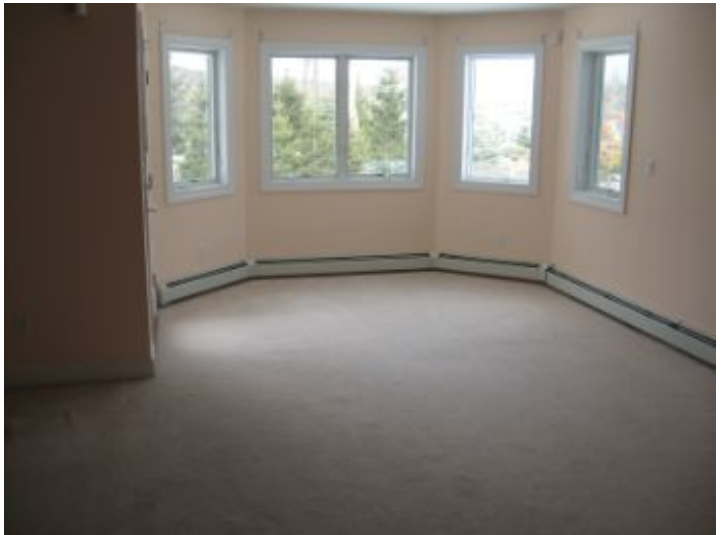
Note: Water stains visible in master bedroom area. After fully inspecting areas of water staining, visible mold like substance observed. Full air quality testing and Bio slide tests recommended and completed at this time.

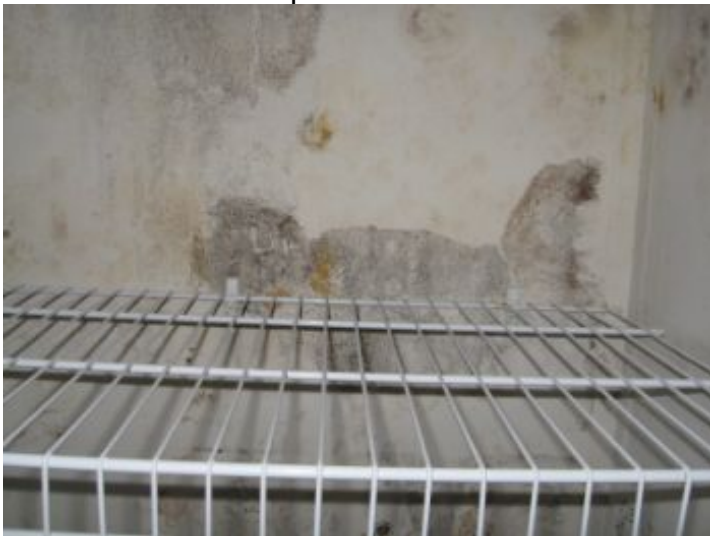
Note: Water stains visible in master bedroom area. After fully inspecting areas of water staining, visible mold like substance observed. Full air quality testing and Bio slide tests recommended and completed at this time.

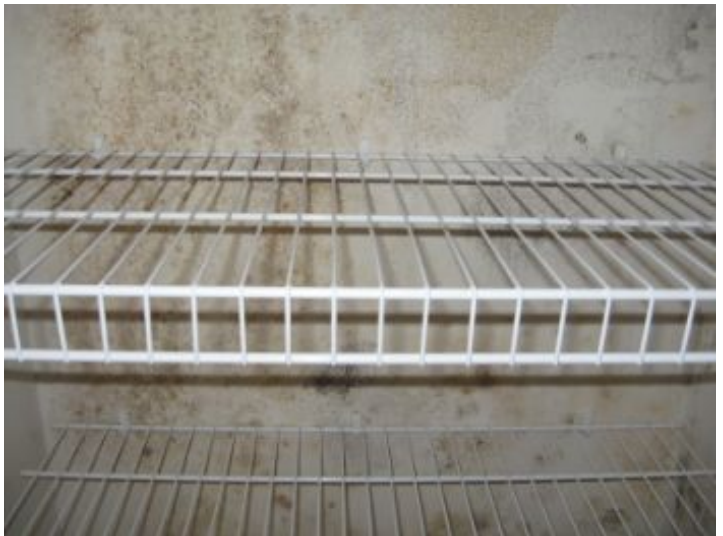
Note: Water stains visible in master bedroom area. After fully inspecting areas of water staining, visible mold like substance observed. Full air quality testing and Bio slide tests recommended and completed at this time.

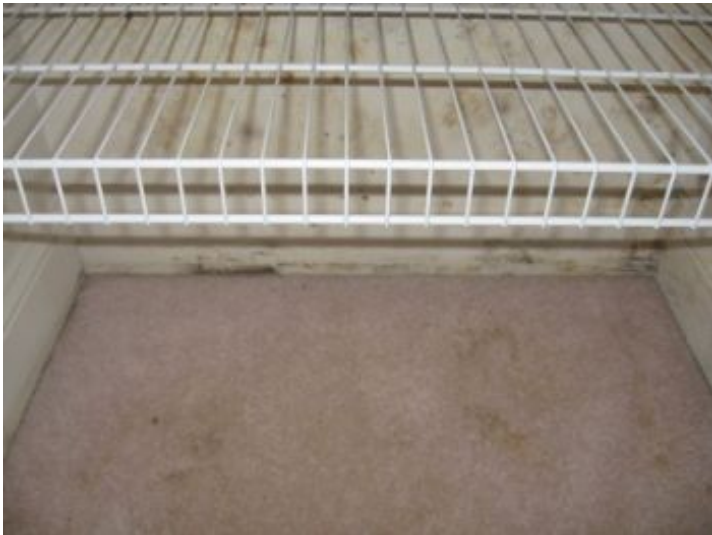
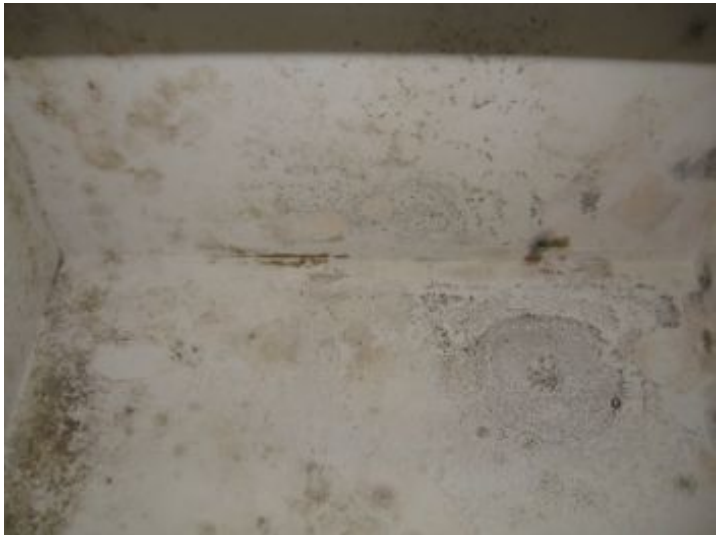
Note: Water stains visible in master bedroom area. After fully inspecting areas of water staining, visible mold like substance observed. Full air quality testing and Bio slide tests recommended and completed at this time.

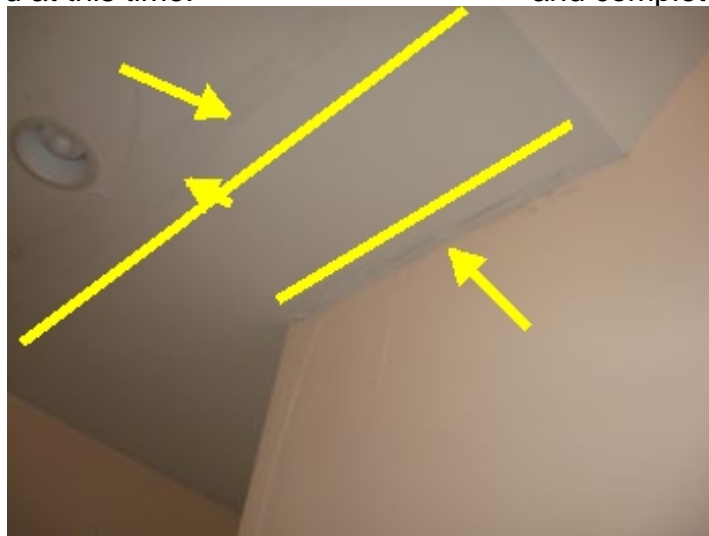
Note: Water stains visible in master bedroom area. After fully inspecting areas of water staining, visible mold like substance observed. Full air quality testing and Bio slide tests recommended and completed at this time.

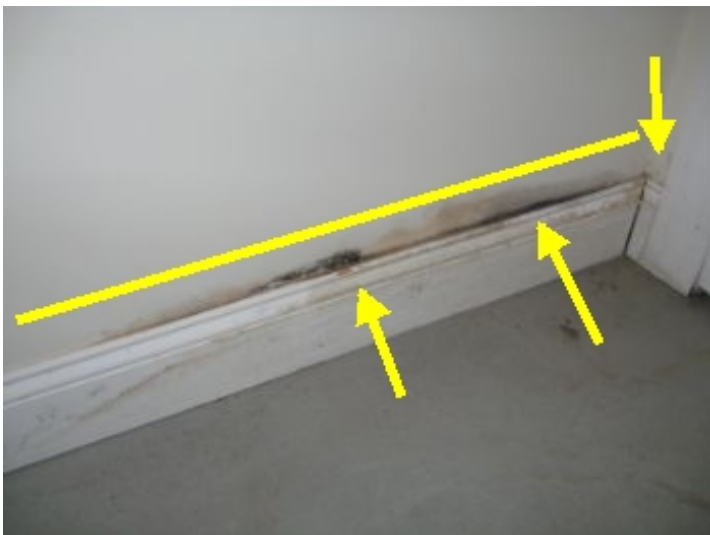
There is evidence of moisture intrusion in the basement at the northwest outside wall, recommend further evaluation as to cause and repairs. Bio slide samples taken.

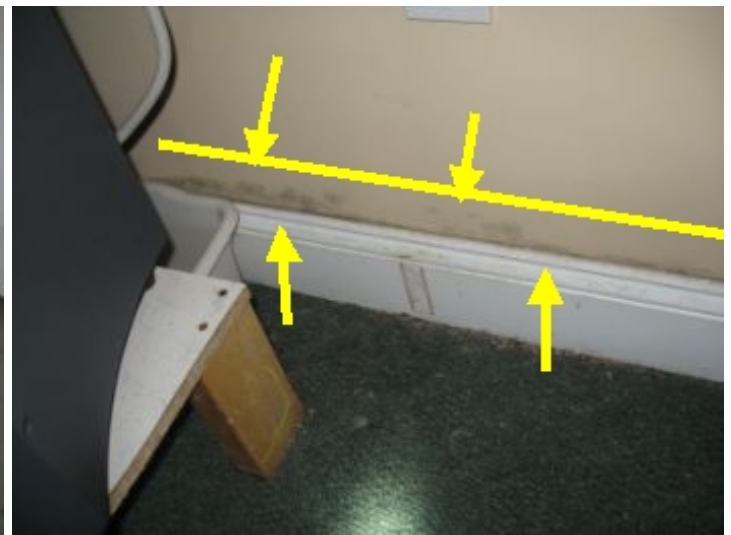
There is evidence of moisture intrusion in the basement at the northwest outside wall, recommend further evaluation as to cause and repairs. Bio slide samples taken.

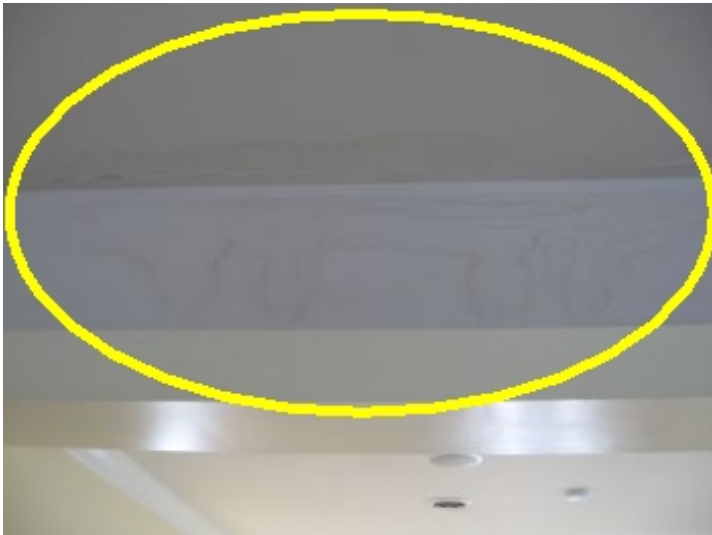
There is evidence of moisture intrusion in the master bedroom ceiling areas: After further inspection it was determined that the condensate pump discharge tube is damaged and leaking into the attic. Immediate repairs recommended. Air quality sampling and Bio slide samples taken from the master bed room and master closet area at this time.

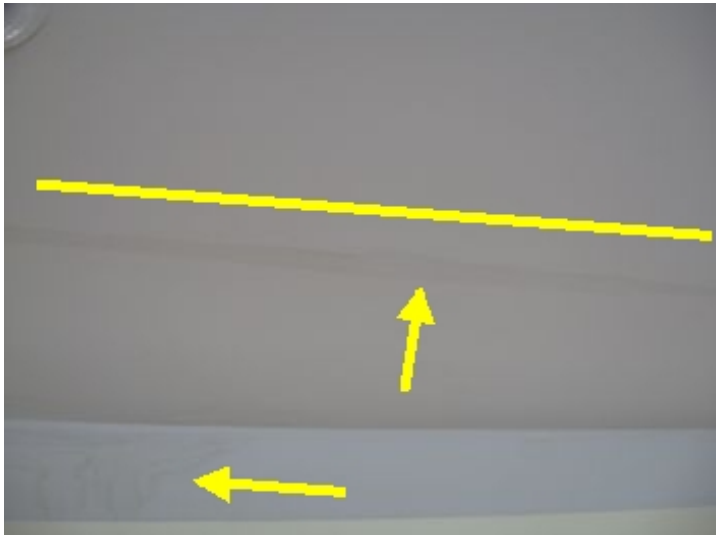
There is evidence of moisture intrusion in the master bedroom ceiling areas: After further inspection it was determined that the condensate pump discharge tube is damaged and leaking into the attic. Immediate repairs recommended. Air quality sampling and Bio slide samples taken from the master bed room and master closet area at this time.

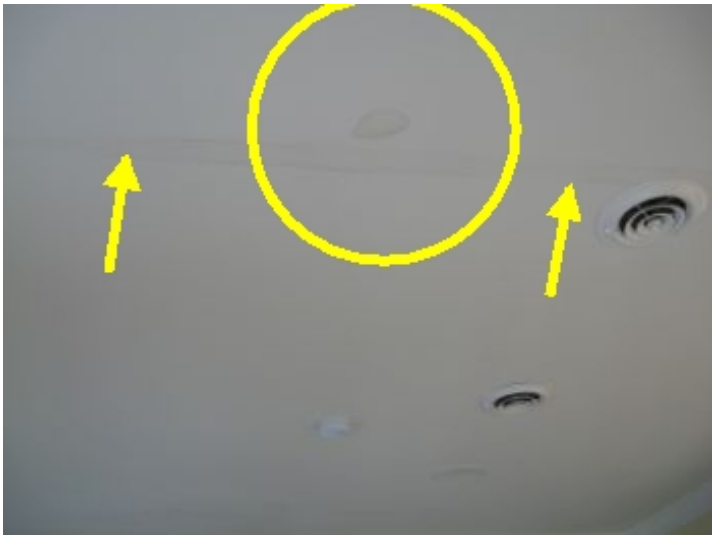
There is evidence of moisture intrusion in the master bedroom ceiling areas: After further inspection it was determined that the condensate pump discharge tube is damaged and leaking into the attic. Immediate repairs recommended. Air quality sampling and Bio slide samples taken from the master bed room and master closet area at this time.

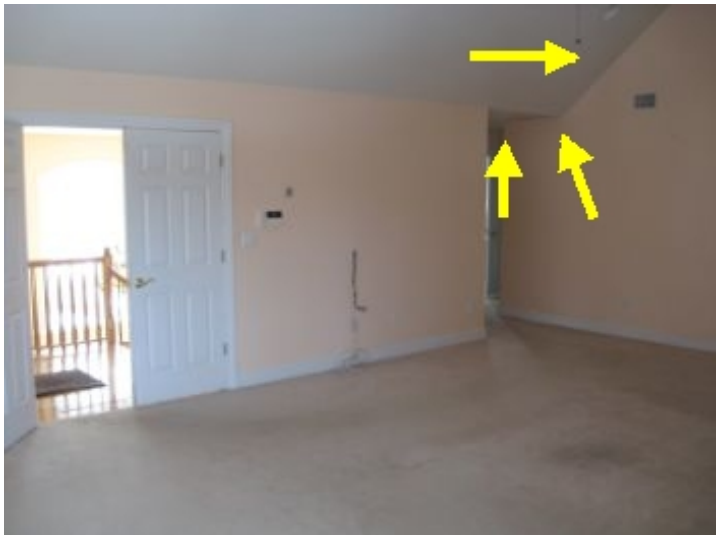
There is evidence of moisture intrusion in the master bedroom ceiling areas: After further inspection it was determined that the condensate pump discharge tube is damaged and leaking into the attic. Immediate repairs recommended. Air quality sampling and Bio slide samples taken from the master bed room and master closet area at this time.

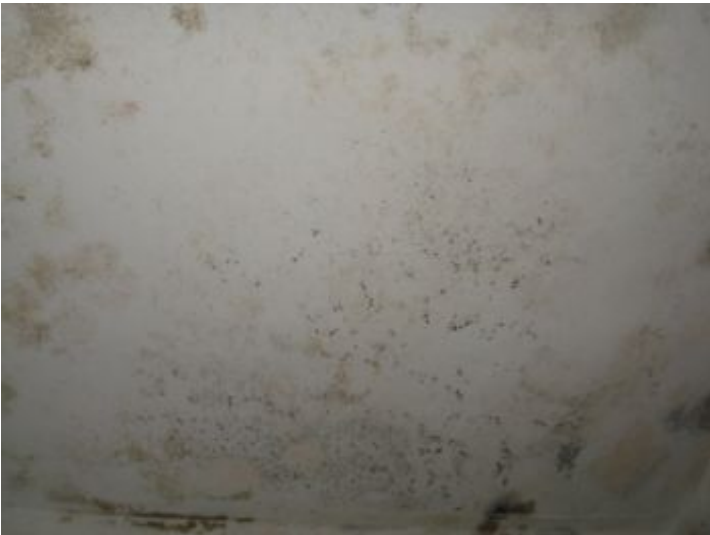
There is evidence of moisture intrusion in the master bedroom ceiling areas: After further inspection it was determined that the condensate pump discharge tube is damaged and leaking into the attic. Immediate repairs recommended. Air quality sampling and Bio slide samples taken from the master bed room and master closet area at this time.

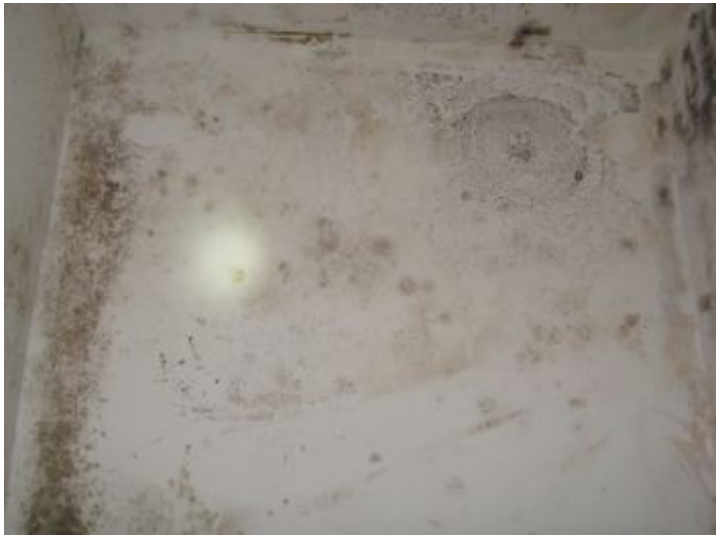
There is evidence of moisture intrusion in the master bedroom ceiling areas: After further inspection it was determined that the condensate pump discharge tube is damaged and leaking into the attic. Immediate repairs recommended. Air quality sampling and Bio slide samples taken from the master bed room and master closet area at this time.

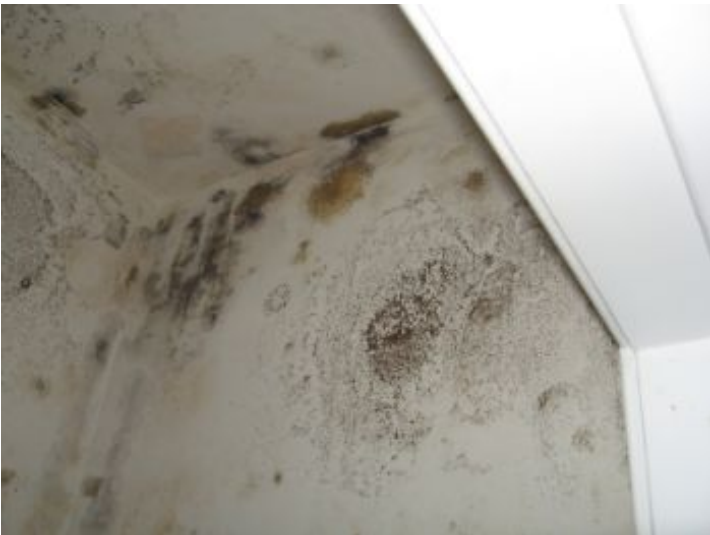
There is evidence of moisture intrusion in the master bedroom ceiling areas: After further inspection it was determined that the condensate pump discharge tube is damaged and leaking into the attic. Immediate repairs recommended. Air quality sampling and Bio slide samples taken from the master bed room and master closet area at this time.

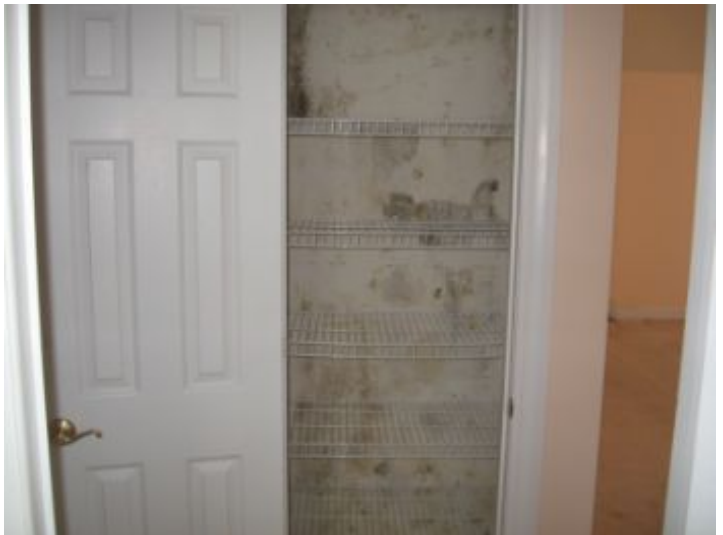
There is evidence of moisture intrusion in the master bedroom ceiling areas: After further inspection it was determined that the condensate pump discharge tube is damaged and leaking into the attic. Immediate repairs recommended. Air quality sampling and Bio slide samples taken from the master bed room and master closet area at this time. Mold Like substance visible testing completed at this time.
